# **ENERGY AUDIT POST INSTALLATION REPORT**

## **Results and Recommendations from Energy Audit of Beaver**

### **For VEEP Grants City of Beaver, Alaska**

**June 20, 2012**

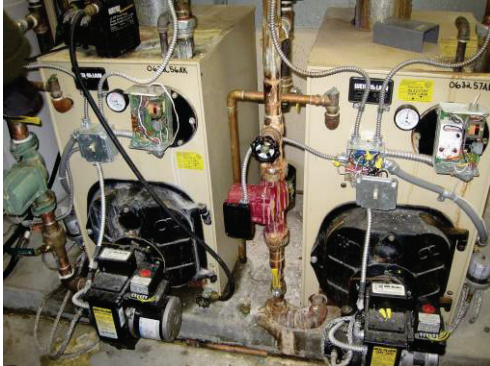
**Heating:** Two Weil-McLain fuel oil WTGO-7 boilers provide heating to the building. These boilers are listed as 85% AFUE. Only one of the boilers was functioning at the time of the audit. A combustion analysis found the operational boiler to be performing at 83.8% combustion efficiency.

*Weil-McLain Boilers*

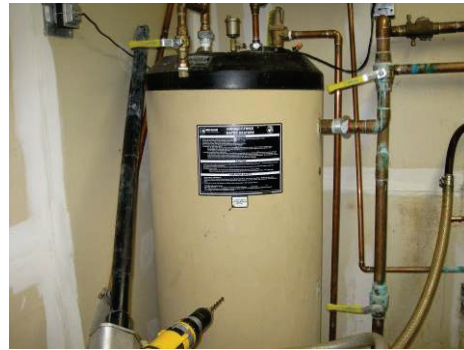
**Domestic Water:** A Weil-McLain indirect fired water heater provides the building with domestic hot water. At the time of the audit, the water had been shut off due to frozen pipes and because of problems at the lift station. Several other pipes were disconnected for unknown reasons. None of the hydronic pipes are insulated.

*Weil-McLain Indirect-fired Water Heater*

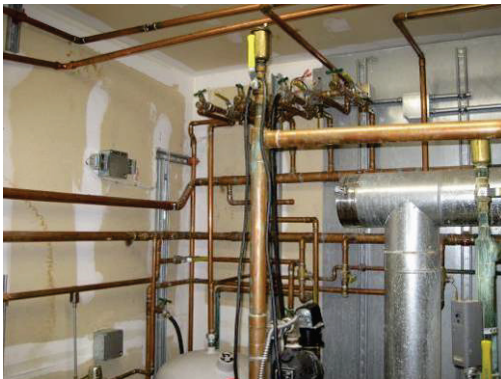
*Uninsulated Hydronic Piping System*

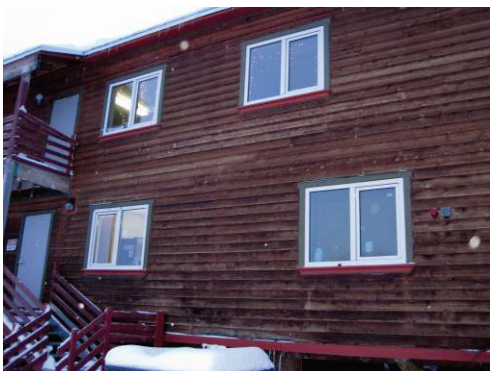
*Exterior Windows in Good Condition*

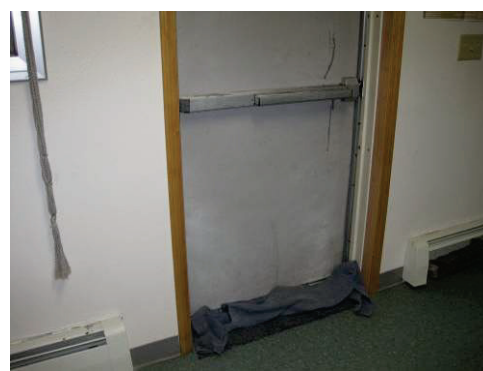
**Building Envelope:** The building envelope components are in good condition. The roof appears to be in good condition, with no signs of leakage or major damage. Exterior windows are in good condition, with no broken panes. Doors are in good condition, but exterior weather-stripping is in poor condition and needs to be replaced.

*Makeshift Weatherization*

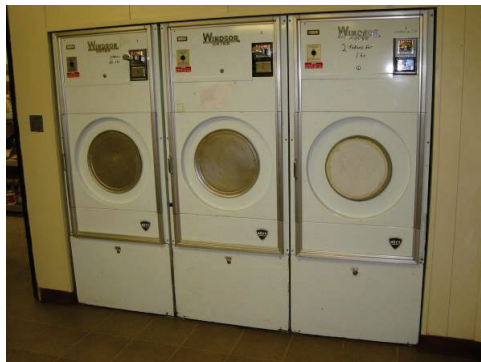
**Laundry Equipment:** Three Hoyt Windsor dryers and two Maytag washers satisfy the Washeteria's laundering requirements. At the time of the audit, one of the dryers was out of order. The washers are older and are not ENERGY STAR rated. An ENERGY STAR rating does not currently exist for dryers, but these are older models as well, and newer more efficient models could generate energy savings.

*Hoyt Windsor Dryers*

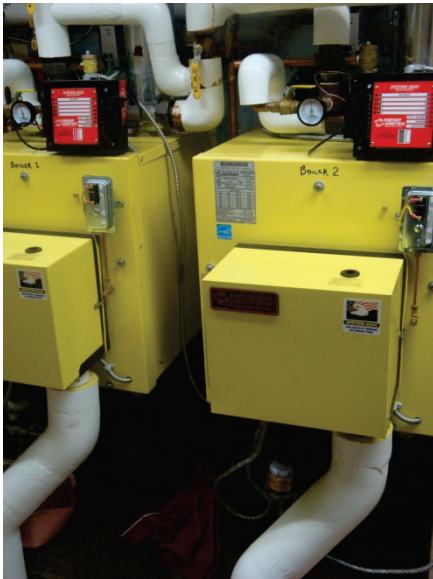
*New Energy Kinetics Boilers*

Installed as planned, but project costs exceeded initial projections.

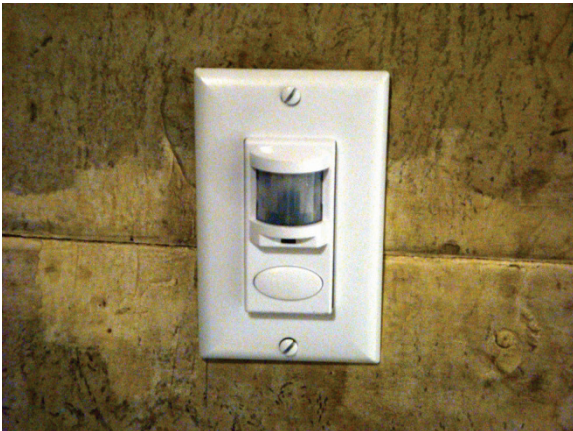
*Installed Occupancy Sensor*

Installed as planned. See *Section 5.2* and *Appendix A* for updated cost information.

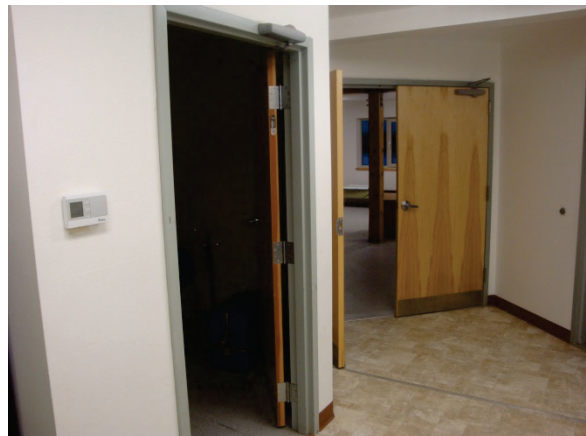
*Programmable Thermostat Installation*

Installed as planned. See *Section 5.2* and *Appendix A* for updated cost information. Note: The savings on this ECO relies on proper HVAC scheduling. If the settings are tampered with, the savings will not be realized.
