# **WIND POWER DEVELOPMENT IN SUB-ARCTIC CONDITIONS WITH SEVERE RIME ICING**

John F. Maissan, P.Eng.,  
Director, Technical Services  
Yukon Energy Corporation

Circumpolar Climate Change Summit and Exposition

March 19-21, 2001  
Whitehorse, Yukon  
Canada

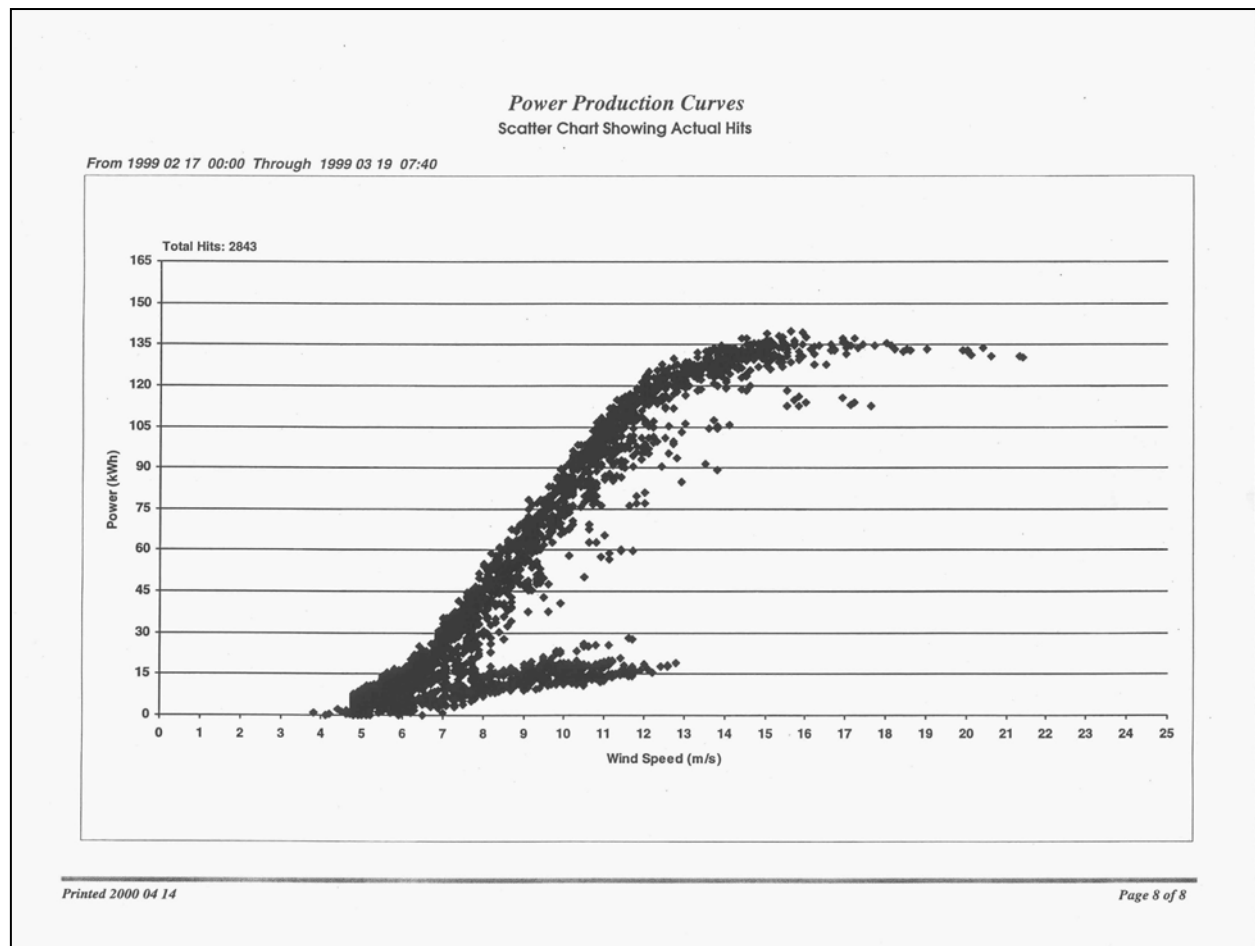
**Graph 1 Rime Icing Effects on Power Production Curves**

The effect of rime icing on the blades of the wind turbine is such an important issue that it is worth examining in detail. Without blade heaters rime ice builds up especially heavily on the leading edges, and the build up increases with distance from the blade root (Photograph 4). It seems to be directly related to the velocity at any point and therefore perhaps the amount of moisture or moist ice contacted. When shut down the ice builds up on the edges of the blade surface facing the wind, the pressure side. When running through an icing event the ice build up on the "back", or suction side, of the blade is much less than on the "front" (Photograph 5). Ice can also build up on the trailing edge. Power production drops off dramatically when the blades are coated with rime ice and without leading edge blade heaters can stop altogether (Graph 1).

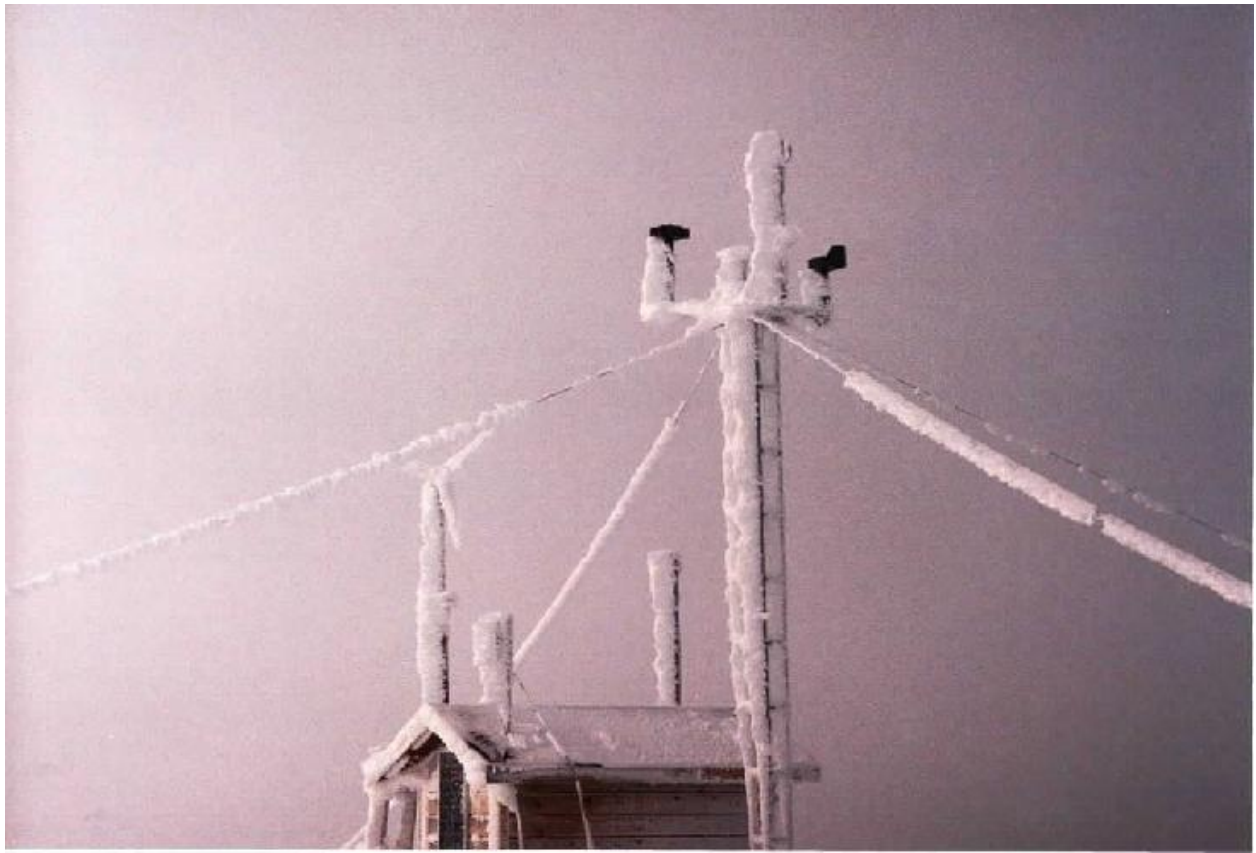
The climate in Whitehorse is sub-arctic, mean daily January lows are -25°C with the lowest temperatures around -40°C, and occasionally to -45°C or lower. Weather data analyses have shown that at altitudes of 4,000 to 6,000 feet rime icing can occur from 800 to 1200 hours per year -- equivalent to a continuous duration of 4 to 7 weeks per year. Rime icing is the buildup of ice on anything solid from moist, supersaturated air at sub-zero temperatures. Essentially whenever and wherever there is a cloud on a mountain there is rime icing (cover photograph). Rime ice looks like the pretty frost that builds up on trees around open water in the winter. In our location rime icing is most severe in the early winter: mid October to the end of December. Severe rime ice on wind monitoring equipment is illustrated in Photograph 1.

Photograph 1: Rime ice on monitoring equipment, only heated instruments stay clear

1. The heated bearing anemometer and wind vane were still immobilized by ice and were replaced with fully heated Hydro-Tech instruments which have not iced up (Photograph 1).

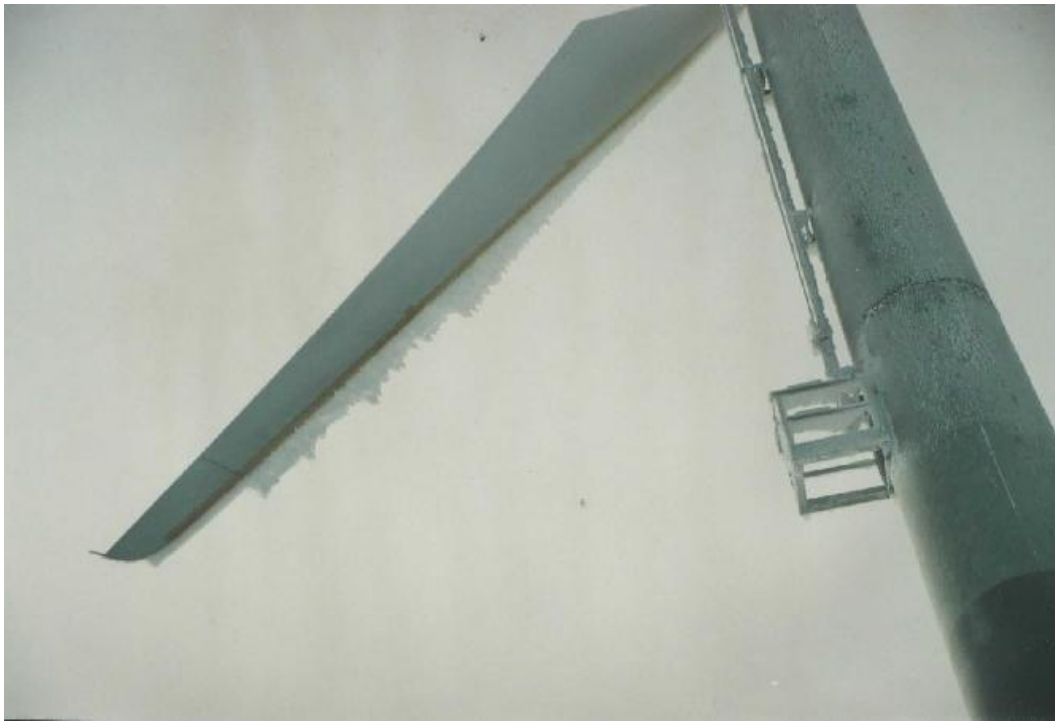
Photograph 5: wedge shape build up from back, note clear back of blade – leading edge heaters not working

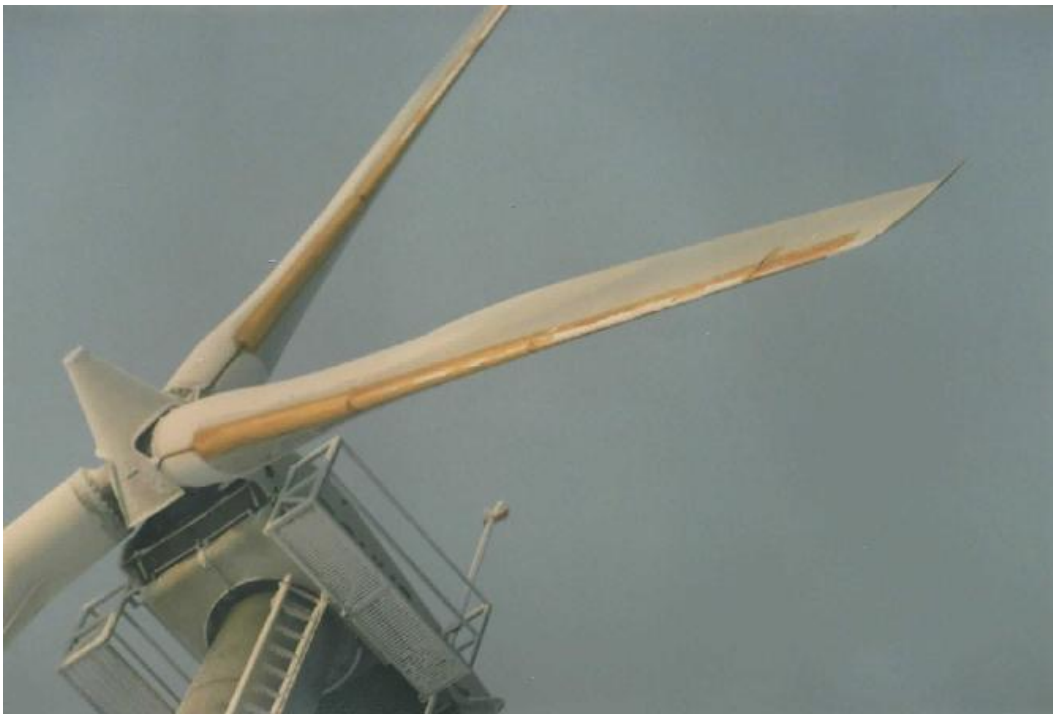
The 6 inch wide heaters did, under lighter icing conditions, keep portions of the blade downwind of the heater clear (Photograph 6). Under heavier icing conditions ice would build up on the blade right up to the heater (Photograph 7). Build up of ice on the leading edges did not occur except under the most severe conditions, and it cleared off quite quickly afterwards. It was from this that we concluded that more heat on the front of the blade in the form of wider leading edge heaters would be of benefit if the increased area was applied to the front (pressure side) of the blade. It was also obvious that the leading edges of the blade tip would need to be heated to minimize the air drag and associated production losses.

Photograph 6: in less severe rime icing the effect of the leading edge heaters extends past the leading edge

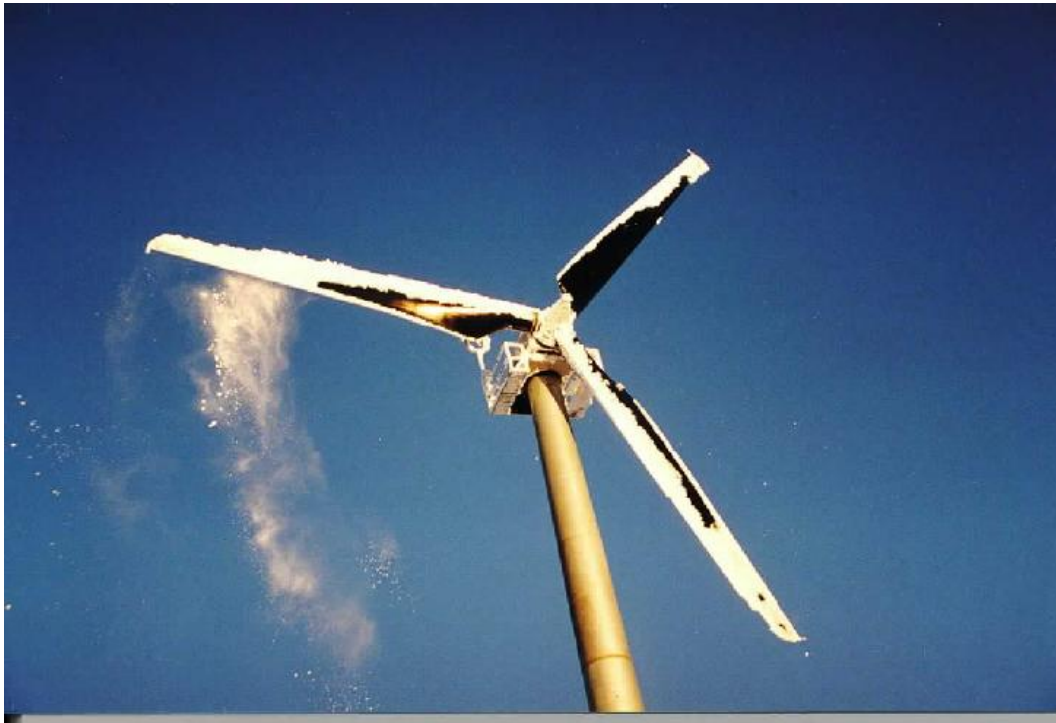
Repairs to the power line (a local feeder) were made in 1996 and since that time there have been very few of the electronic problems that bothered us early on, and turbine availability has been very high. Also in 1996 we "painted" the blades with a black coloured coating called StaClean. We believed that the solar heating from the black colour would assist in clearing the blades of accumulated rime ice, and we felt that the special low adhesion formula for ice could be beneficial too. We saw an immediate noticeable improvement in performance, 1998 and 1999 have been the best production years yet. Photograph 8 shows accumulated ice shedding from the blades.

Photograph 8: accumulated ice shedding from black blades
